SAGE
HOME INSPECTIONS

Property Inspection Report

Property address: **13526 476th Ave SE
North Bend, WA 98045**

Inspection date: **Monday, April 9, 2018**

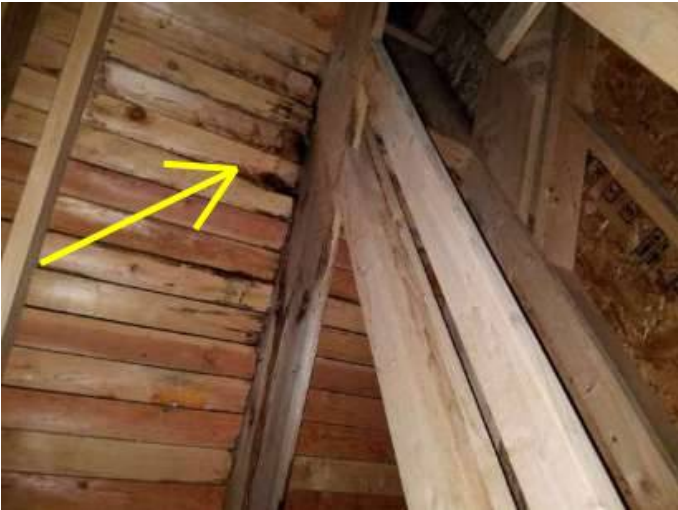
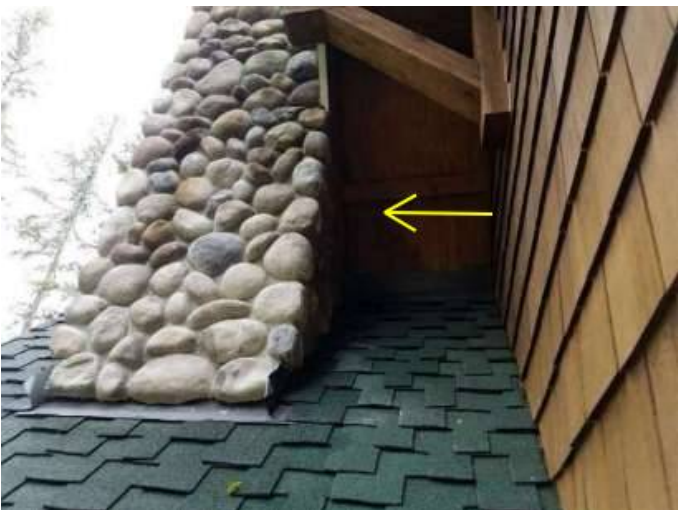
1) *Repair/Replace, Evaluate* - A leak was noted at the chimney. Flashings at the base of the chimney is substandard. Recommend that a qualified contractor evaluate and repair as necessary.

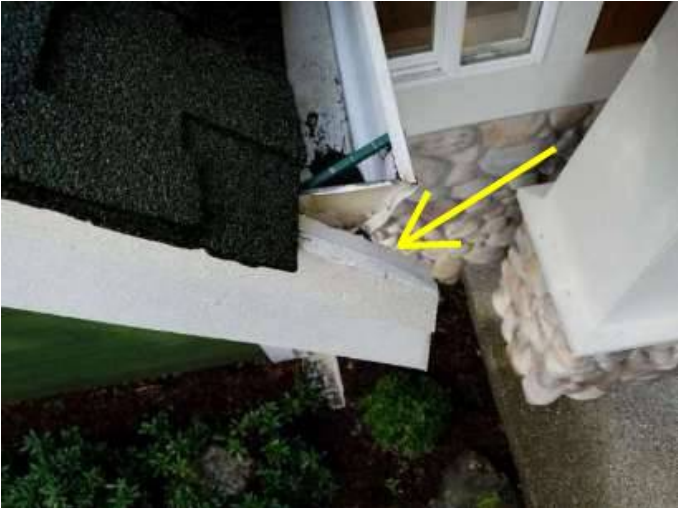
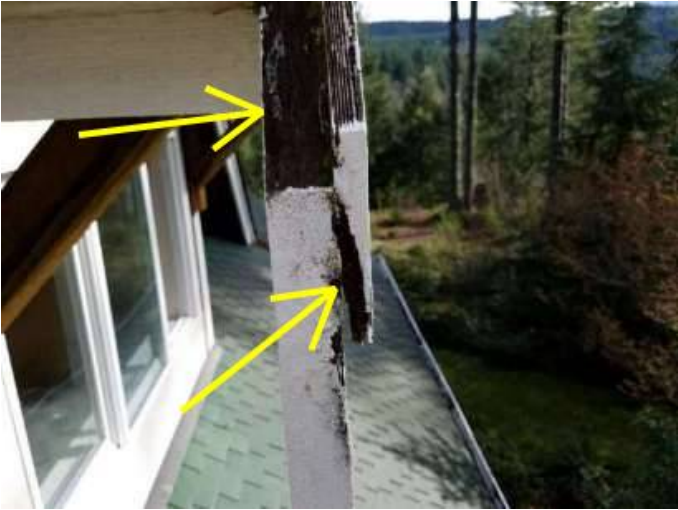
2) *Repair/Replace* - Barge boards, which are the trim boards at gable ends of roofs, were exposed at their lower ends, and some were rotten. Standard building practices call for shingles or flashing to be installed over them to prevent rot. Recommend that a qualified contractor replace rotten boards and install shingles or flashing over exposed barge board ends where missing.

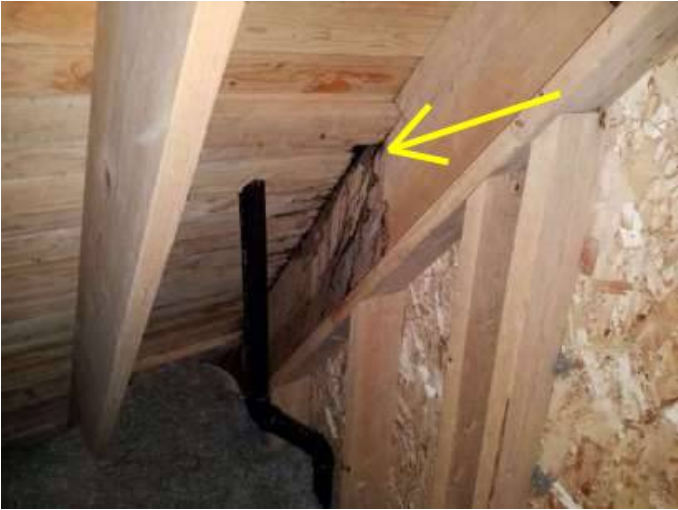
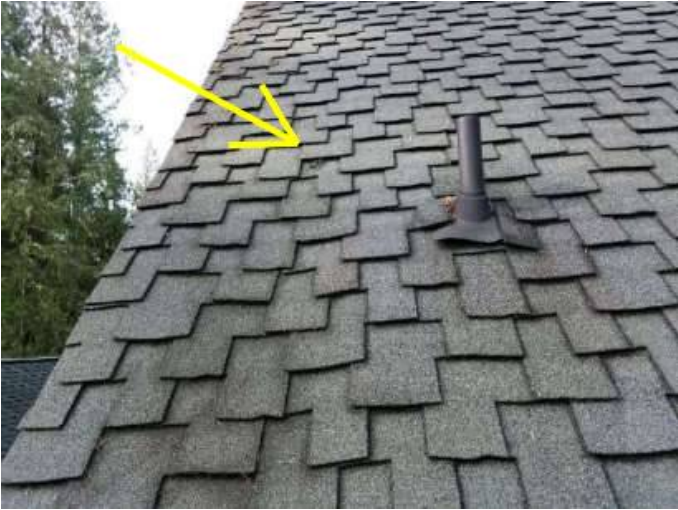
3) ***Repair/Replace*** - A leak was noted on the SE side of the home. A composition shingle in the area is damaged and should be replaced.

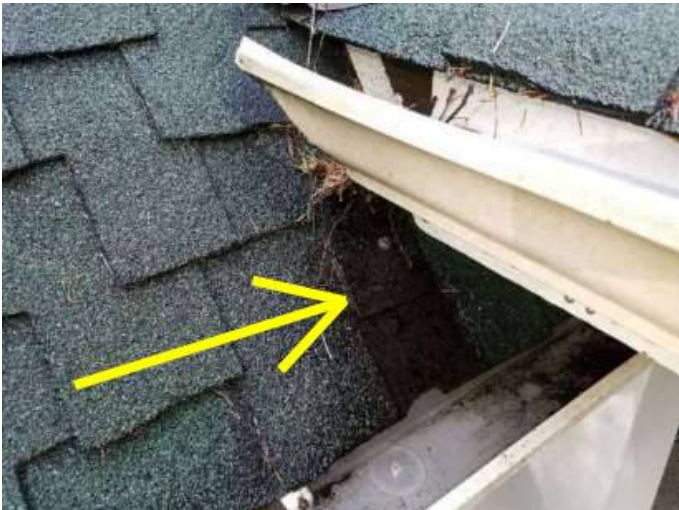
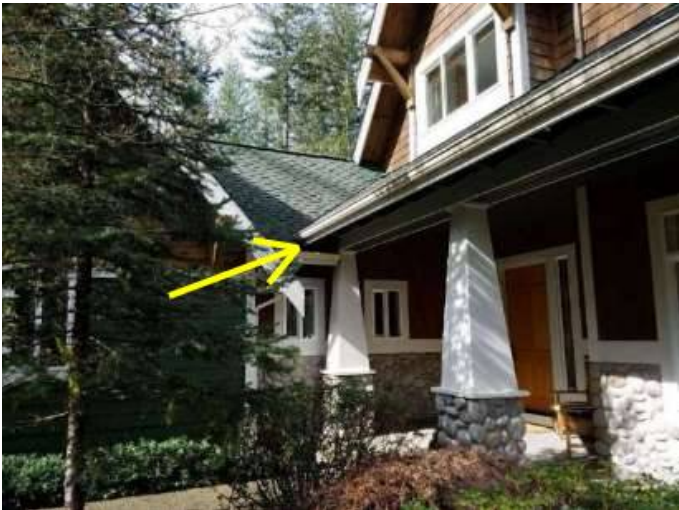
4) ***Repair/Replace*** - One or more downspouts terminated above a roof surface, and rainwater has damaged shingles on the roof surface below. This is a conducive condition for wood-destroying organisms. Downspout installations like this are common, but damage from concentrated rainwater run-off can reduce the life of the roof surface. Recommend that a qualified contractor replace damaged shingles as necessary. Recommend that a qualified person install downspout extensions where necessary to route the rainwater directly to the closest gutter below.

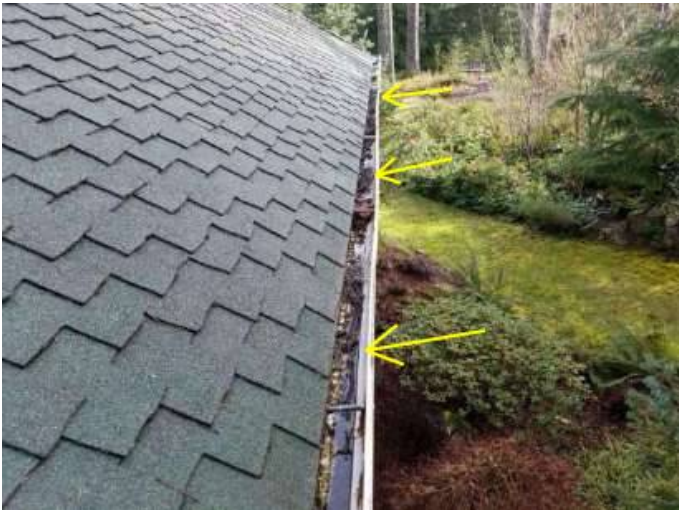
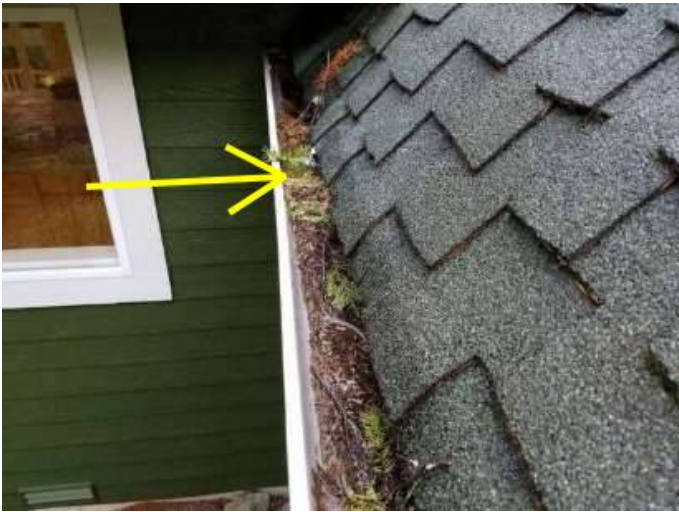
5) *Repair/Maintain* - Debris has accumulated in one or more gutters or downspouts. Gutters can overflow and cause water to come in contact with the building exterior, or water can accumulate around the foundation. Recommend cleaning gutters and downspouts now and as necessary in the future.

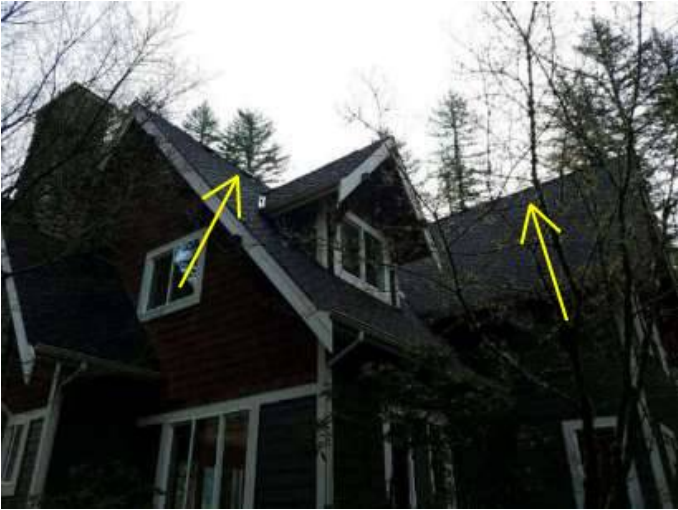
Photo 6-1
North side of home

6) *Repair/Maintain* - 3 roof tie-off brackets were missing their plastic weather caps. Small leaks often occur at the bracket if the cap is missing. Recommend installing proper caps where missing.

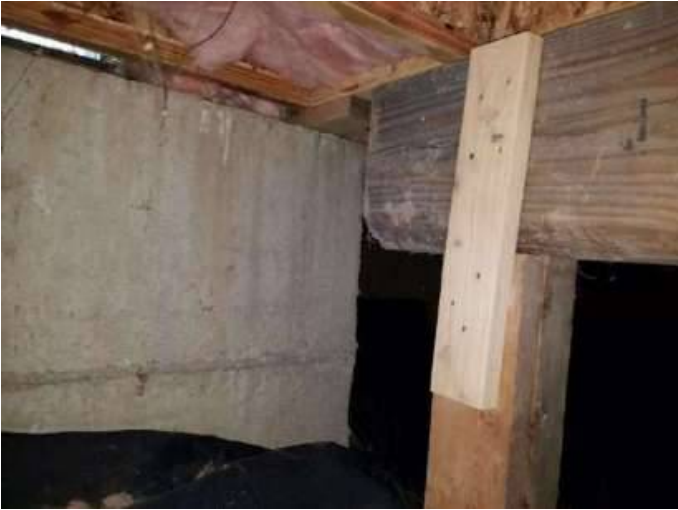
Photo 7-1

7) *Serviceable* - The house appears to be structurally sound. The visible framing members are in good condition with no required repairs noted. There is a poured concrete foundation that is in good condition. The exposed accessible portions of the perimeter foundation walls appeared to be satisfactory. There were no major cracks, and no significant foundation settling at this time. There is also no notable structural settling or sloping of interior floors. There are no suggested repairs at this time.

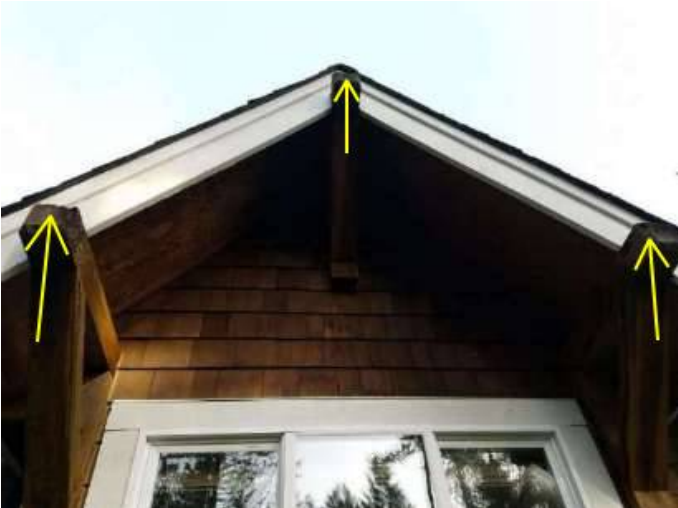
Photo 8-1

8) **Repair/Replace** - Fungal rot was found at one or more exposed decorative corbels. Recommend that a qualified contractor repair or replace as necessary, and place flashing above all corbels to protect them from weather. All rotten wood should be replaced.

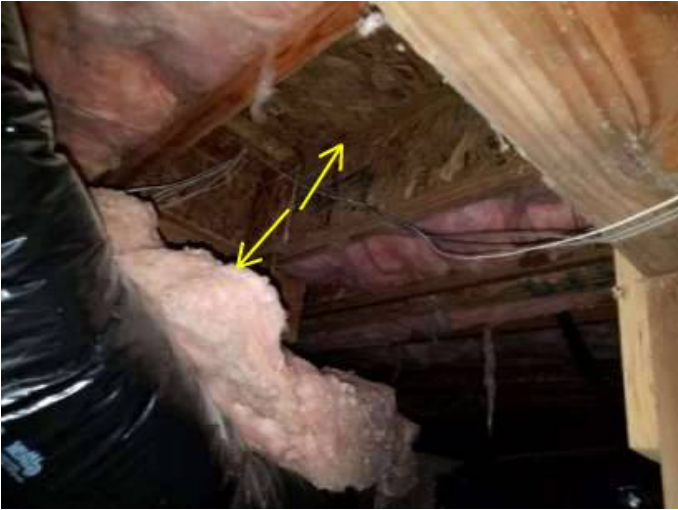
Photo 9-1
Living room area

9) ***Repair/Maintain*** - Under-floor insulation was falling down in one area. This may result in reduced energy efficiency. We recommend that a qualified person repair or replace insulation as necessary.

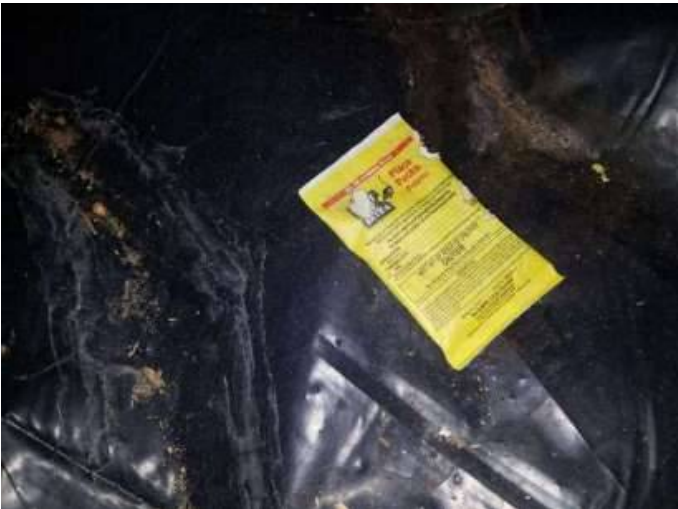
Photo 10-1

10) *Evaluate* - Evidence of a past or present rodent infestation was found in the form of feces, poison and/or damaged insulation in the crawl space. Consult with the property owner about this. A qualified person should make repairs to seal openings in the structure, set traps, and clean rodent waste as necessary. Recommend following guidelines in these Center for Disease Control articles:

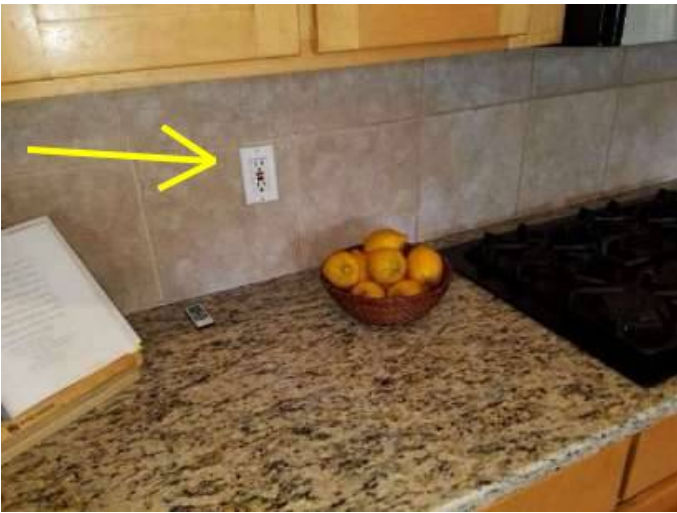
Photo 12-1

12) **Safety, Repair/Replace** - One or more ground fault circuit interrupter (GFCI) devices protecting receptacles at the kitchen wouldn't trip when tested. This is a potential shock hazard. Recommend that a qualified electrician evaluate and repair as necessary.

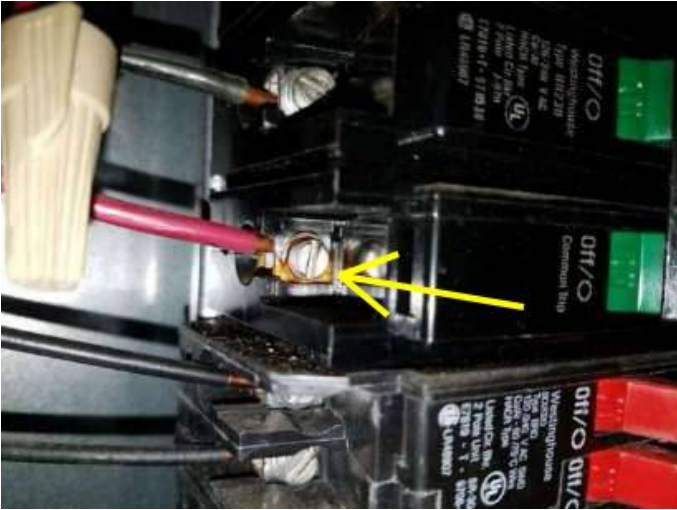
Photo 14-1

14) **Repair/Replace** - One of the circuit breakers in the electrical panel is corroded. Recommend replacement by a qualified electrician.

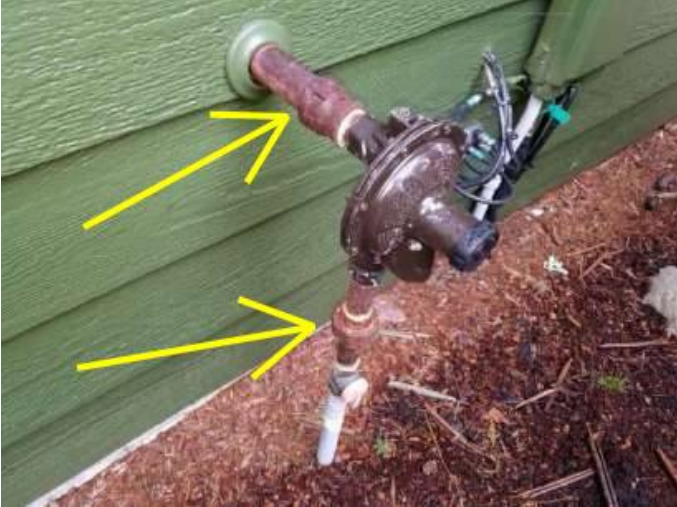
Photo 15-1
SW side of the home

15) *Repair/Maintain* - Steel piping for the gas service located outside was significantly corroded. Gas leaks can result. Recommend evaluation by a qualified contractor to determine if piping needs replacing. If not, then a qualified person should prep and paint lines as necessary with a rust-preventative paint. Very corroded pipes should be replaced by a qualified contractor.

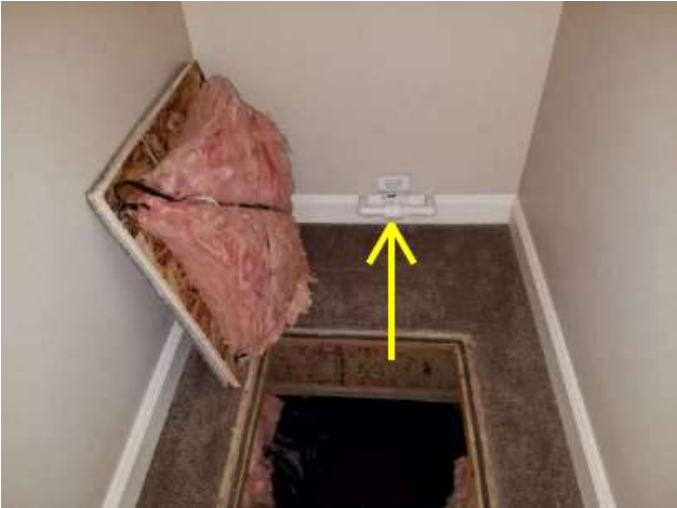
Photo 18-1

18) *Comment* - For informational purposes, the main water shut-off is located in the living room closet.

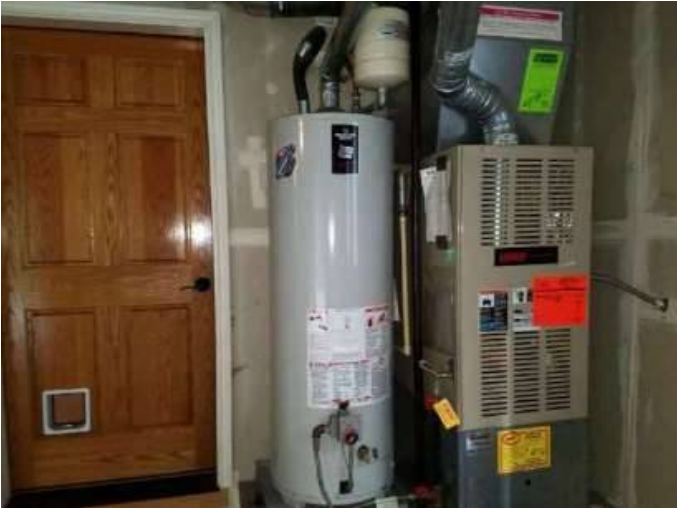
Photo 20-1

20) **Suggest Upgrade** - The water heater is a 20 year old Bradford White brand tank style propane heater with a 50 gallon capacity. It is in serviceable condition, however, it is beyond its expected lifespan and should be replaced as soon as possible. Note that the estimated useful life for most water heaters is 8-12 years.

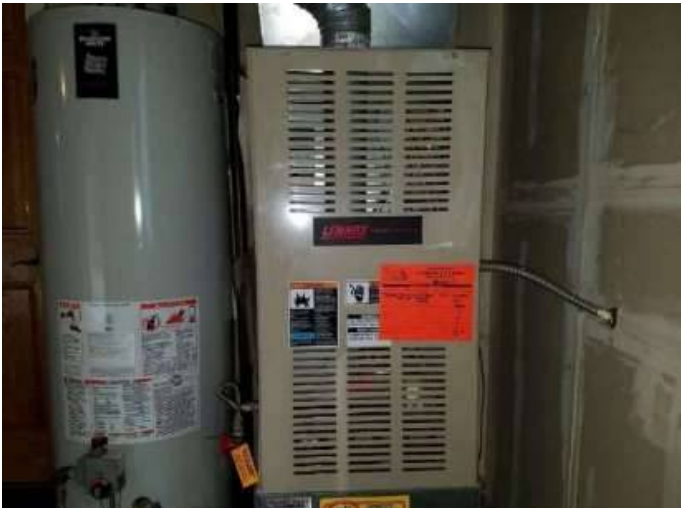
Photo 21-1

21) **Serviceable** - The home has a 20 year old Lennox propane furnace. It is in good operating condition. The burners, flame, combustion air, flue piping, ducting, and registers all appear to be in good condition. The furnace was serviced within the last year and does not need any maintenance at this time. It is generally recommended to have the furnace cleaned and serviced on a yearly basis. Note that furnaces typically last around 20-25 years if they are maintained and serviced frequently.

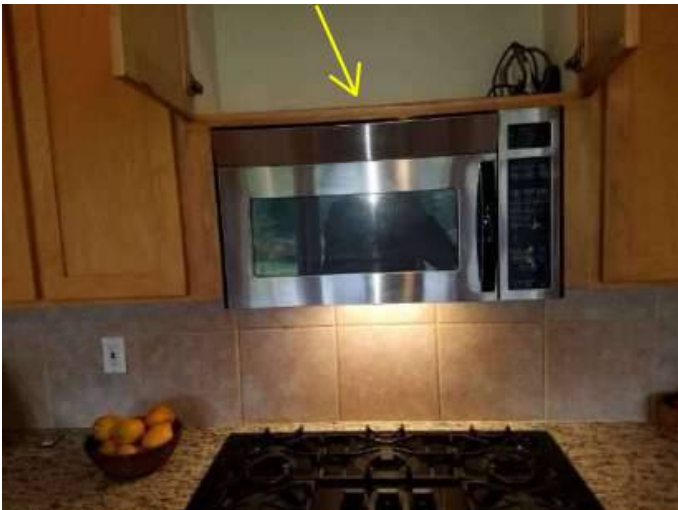
Photo 22-1

22) *Repair/Replace, Suggest Upgrade* - The exhaust fan over the range recirculated the exhaust air back into the kitchen. This may be due to no duct being installed, baffles not being installed, or problems with duct work. This can be a nuisance for odor and grease accumulation. Where a gas-fired range or cooktop is installed, carbon monoxide and excessive levels of moisture can accumulate in living spaces. Recommend that a qualified contractor evaluate and repair as necessary so exhaust air is ducted outdoors.

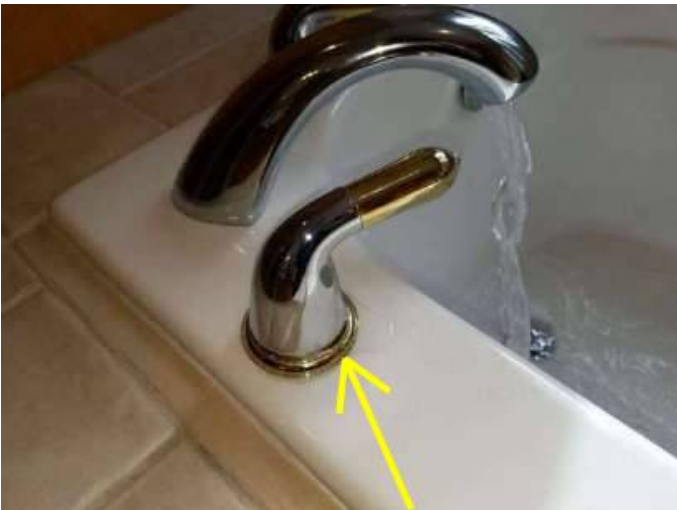
Photo 23-1

23) **Repair/Replace** - One or more bathtub faucet handles at the master bathroom tub were leaking. Recommend that a qualified person repair or replace handles as necessary.

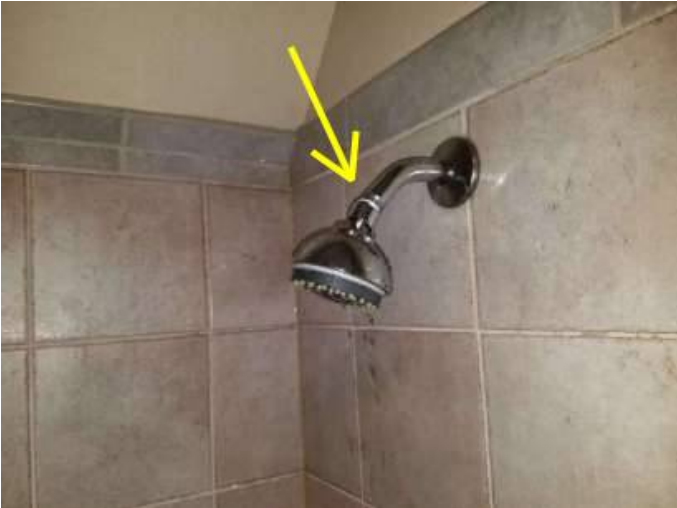
Photo 24-1

24) **Repair/Maintain** - The shower head at the 2nd floor hall bath was leaking. Recommend that a qualified person repair as necessary.

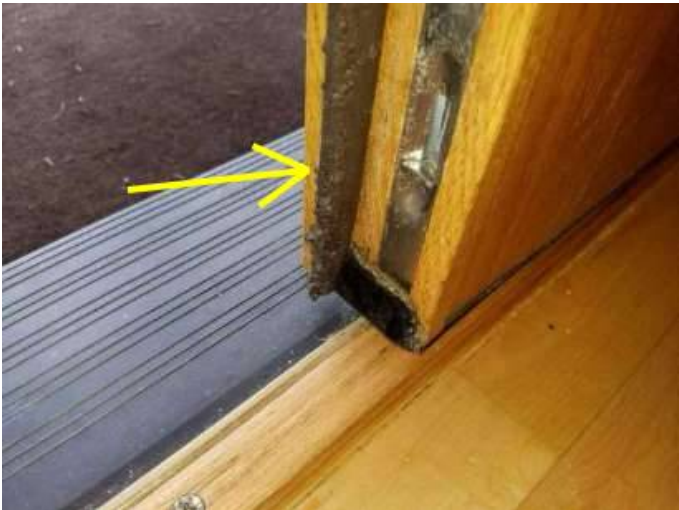
Photo 25-1
Patio french doors

25) *Repair/Maintain* - Weatherstripping around one or more exterior doors was damaged. Water may enter the building, or energy efficiency may be reduced. Recommend that a qualified person repair or replace weatherstripping as necessary.

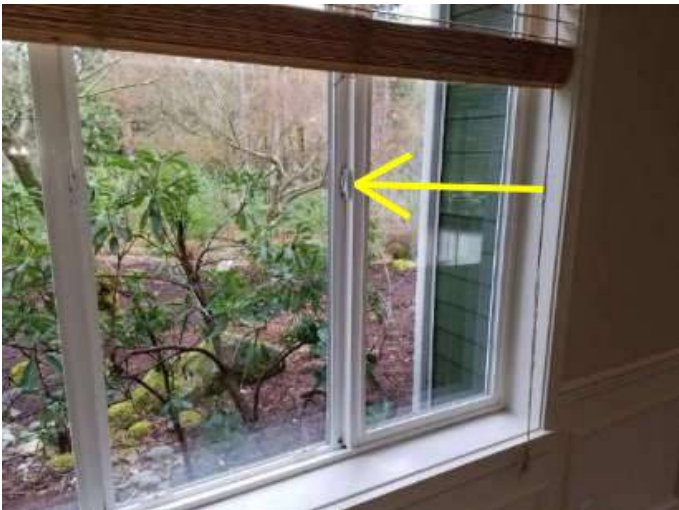
Photo 26-1
Loose lock mechanism in the living room

26) *Repair/Maintain* - Lock mechanisms on one or more windows were loose and/or missing. This can pose a security risk. Recommend that a qualified person repair as necessary.

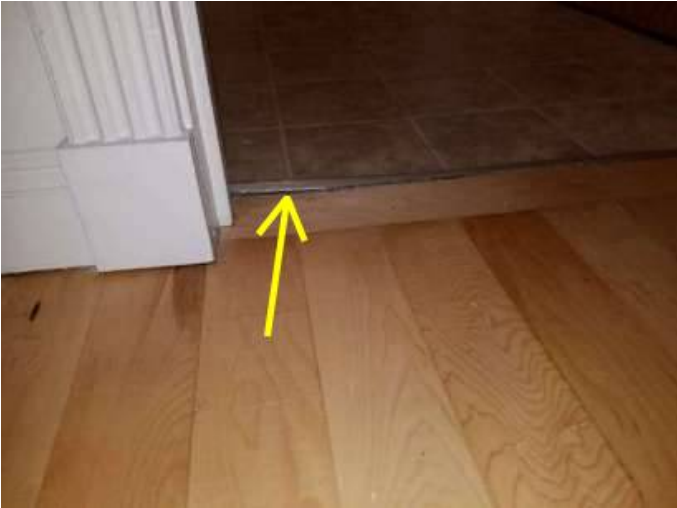
Photo 27-1

27) *Repair/Maintain* - A transition strip was loose at the laundry room. Recommend that a qualified contractor repair as necessary.

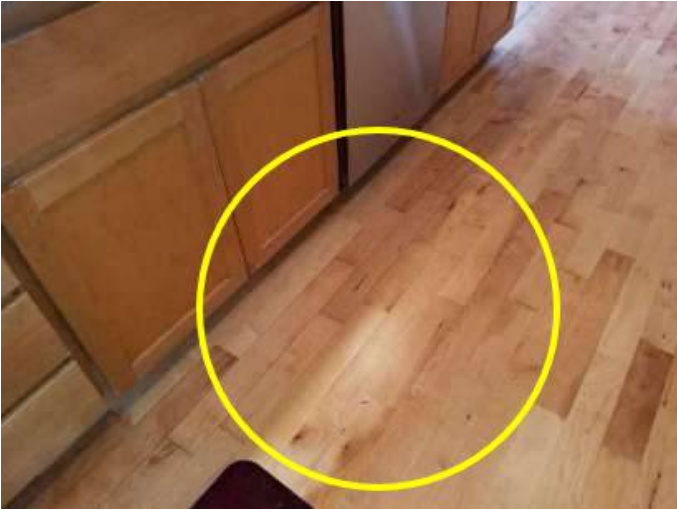
Photo 28-1
Kitchen floor in front of the sink and dishwasher

28) *Evaluate* - Wood flooring in one or more areas was cupping slightly. This may indicate that the floor has been exposed to water or that the flooring was not allowed to equalize in moisture content before being installed. Consult with the property owner and/or have a qualified specialist evaluate. It's likely that affected areas of the wood flooring will need to be refinished to obtain a flat surface. For more information, visit: <http://www.reporthost.com/?WDFLRPRB>

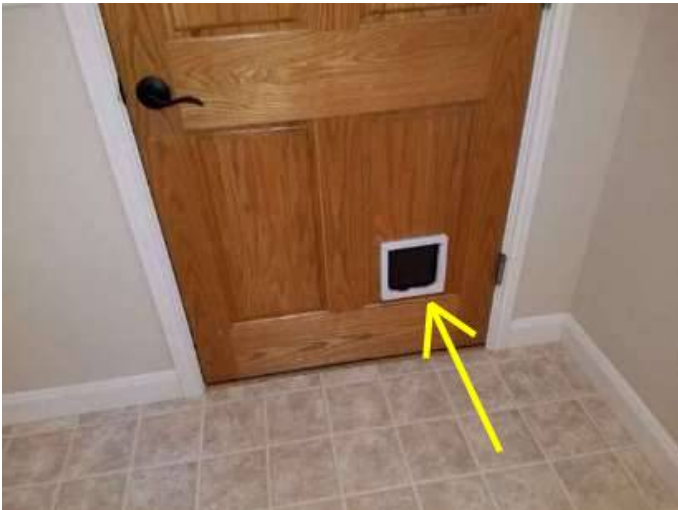
Photo 30-1

30) *Repair/Replace* - The door between the garage and the house has been modified with a pet door, and is no longer fire-resistant. This is a potential safety hazard. House to garage doors, to prevent fire and fumes from spreading from the garage into interior living space, should be constructed of fire-resistant materials. Doors, generally considered to be suitable for the purpose, are solid core wood, steel, honeycomb steel or a door that has been factory labeled as fire rated. Recommend that a qualified contractor replace or repair the door and, at that time, make any other corrections that might be required to provide suitable fire resistance between the garage and the dwelling per standard building practices. For more information, visit:

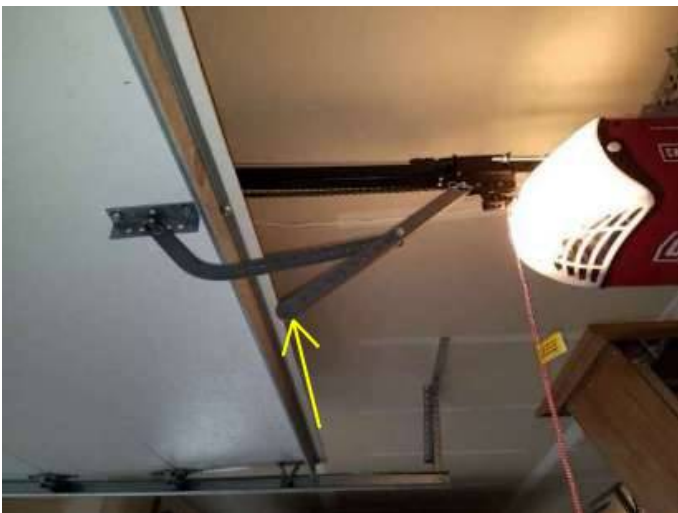
Photo 31-1
Missing bolt

31) *Repair/Maintain* - One or more automatic door openers were loose and/or missing hardware. Recommend that a qualified contractor evaluate and repair or opener(s) as necessary.
