SAGE
HOME INSPECTIONS

Property Inspection Report

Property address: **13526 476th Ave SE
North Bend, WA 98045**

Inspection date: **Monday, April 9, 2018**

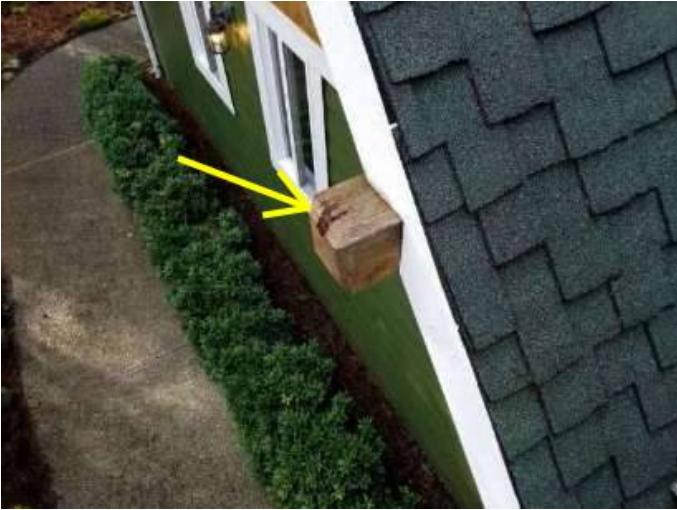
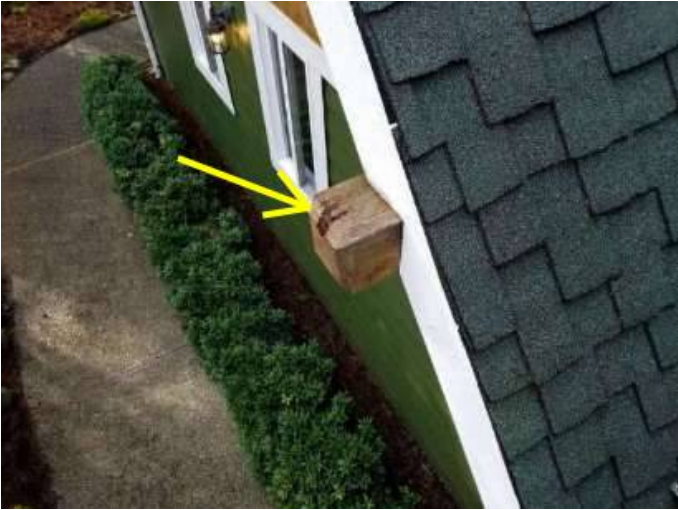
Photo 8-2

8) **Repair/Replace** - Fungal rot was found at one or more exposed decorative corbels. Recommend that a qualified contractor repair or replace as necessary, and place flashing above all corbels to protect them from weather. All rotten wood should be replaced.

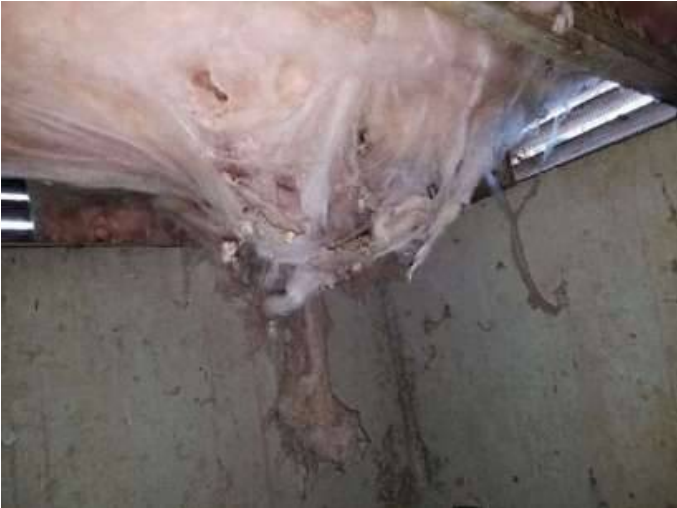
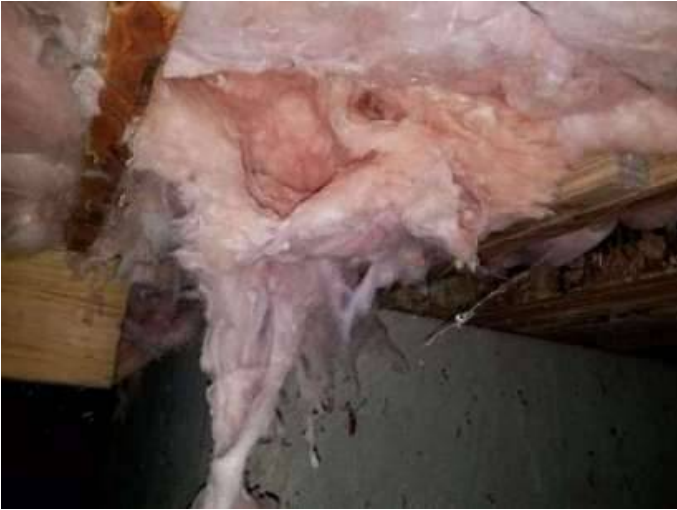
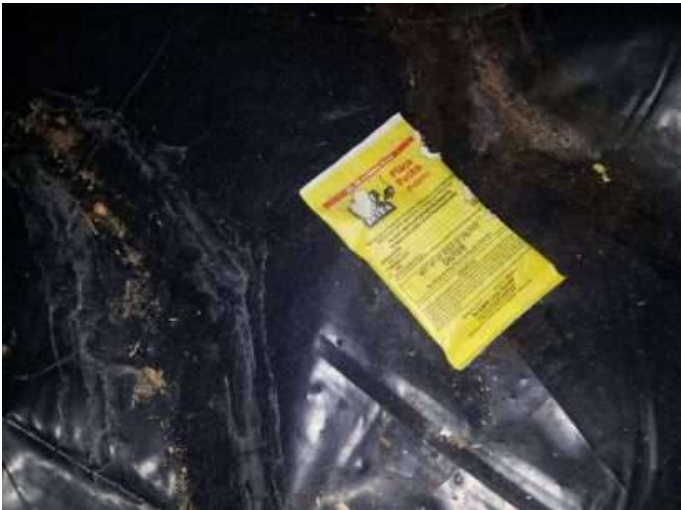
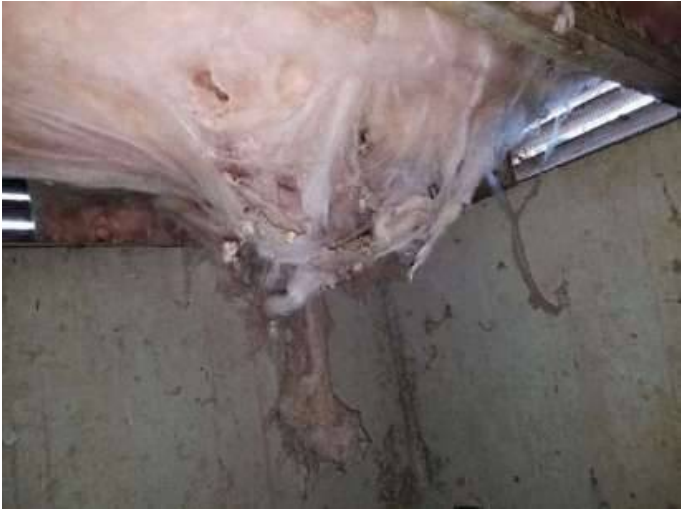
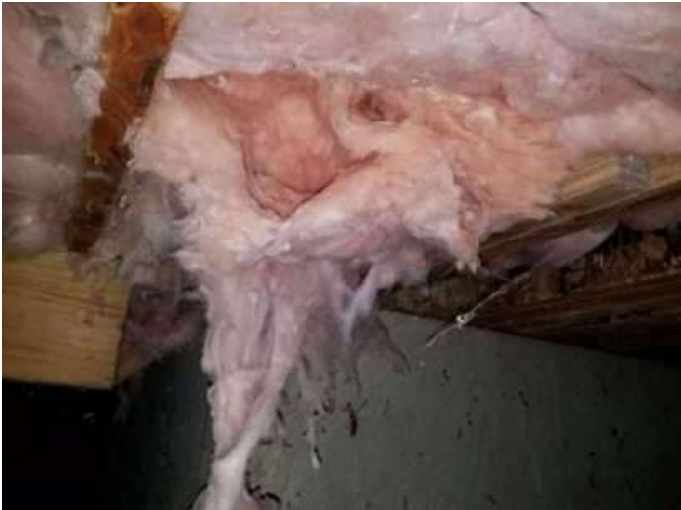
10 *Evaluate* - Evidence of a past or present rodent infestation was found in the form of feces, poison and/or damaged insulation in the crawl space. Consult with the property owner about this. A qualified person should make repairs to seal openings in the structure, set traps, and clean rodent waste as necessary. Recommend following guidelines in these Center for Disease Control articles:

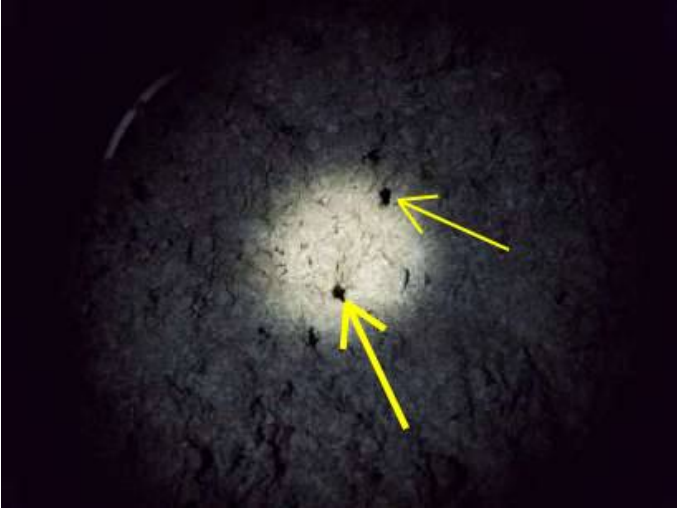
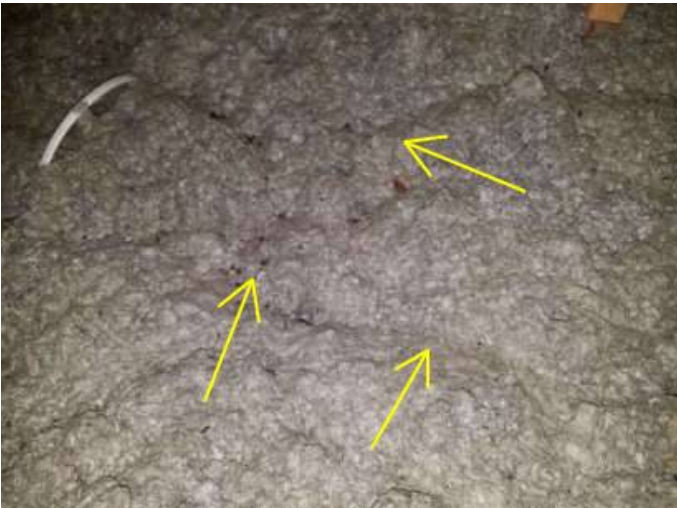
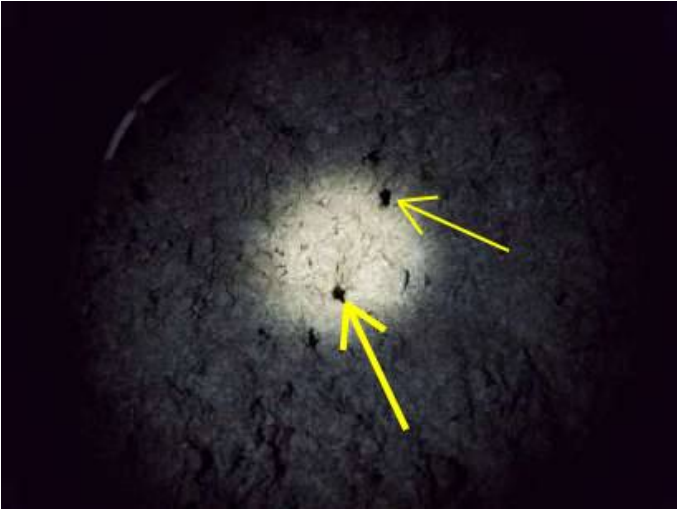
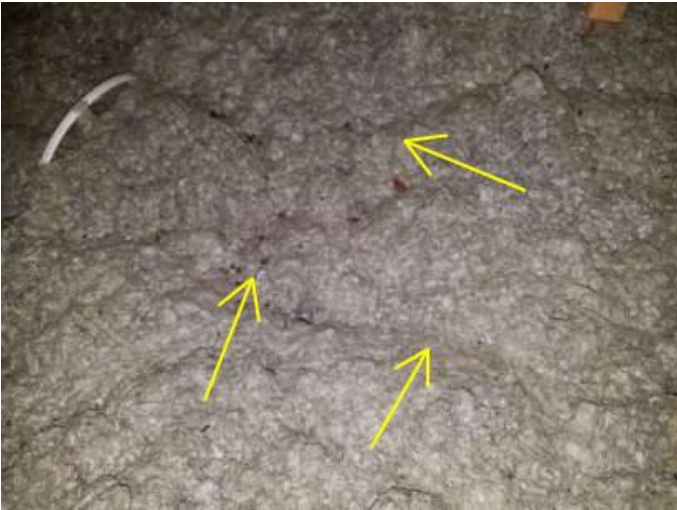
11) *Evaluate* - Evidence of a past or present rodent infestation was found in the form of feces and damaged insulation in the attic. Consult with the property owner about this. A qualified person should make repairs to seal openings in the structure, set traps, and clean rodent waste as necessary. Recommend following guidelines in these Center for Disease Control articles:

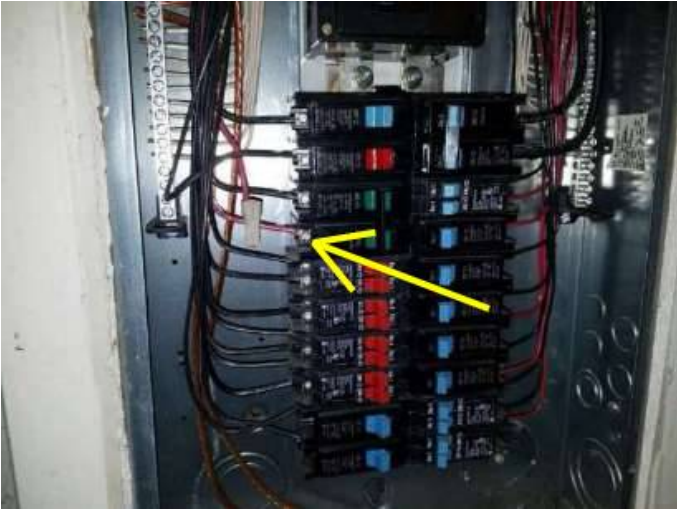
Photo 14-2

14) **Repair/Replace** - One of the circuit breakers in the electrical panel is corroded. Recommend replacement by a qualified electrician.

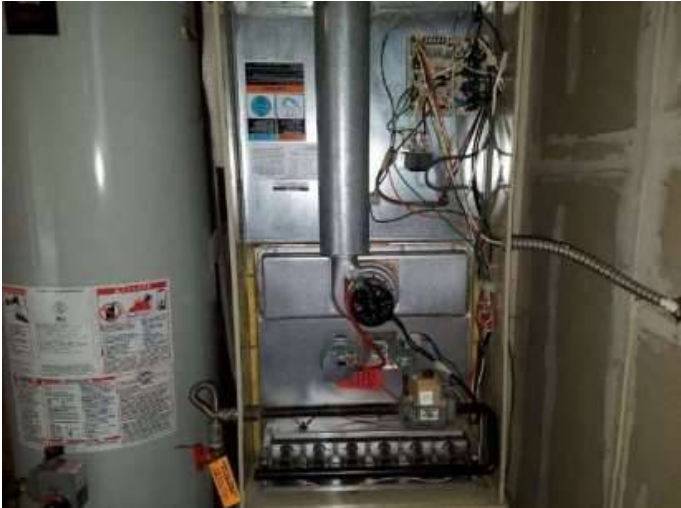
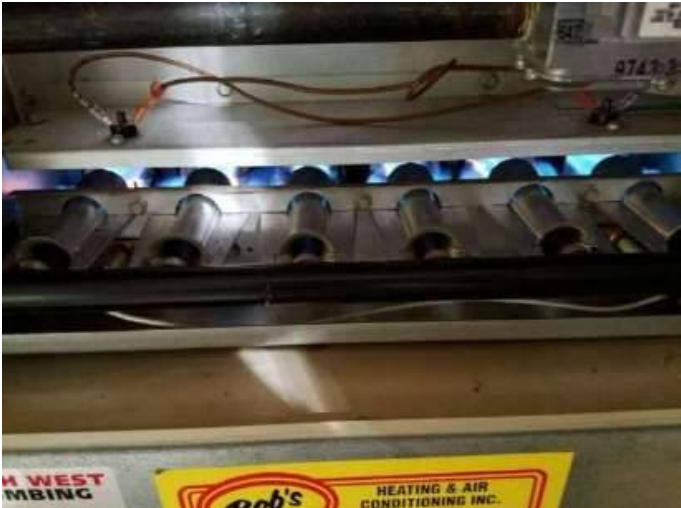
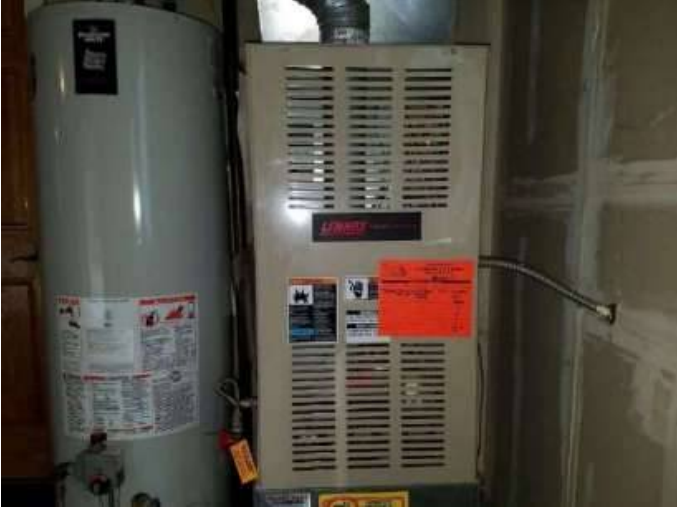
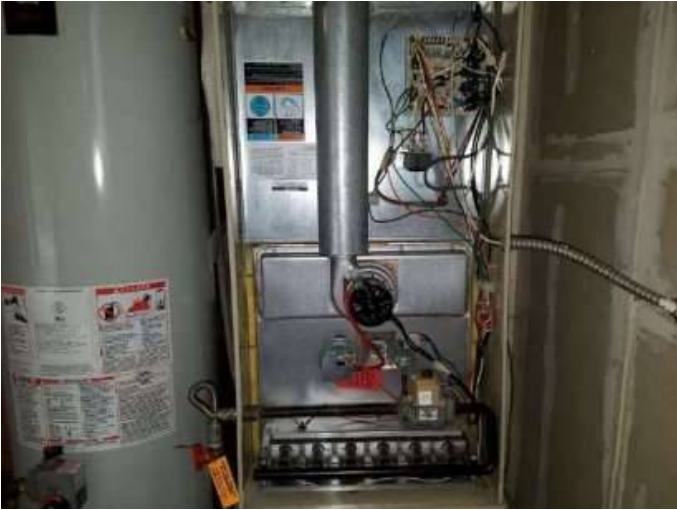
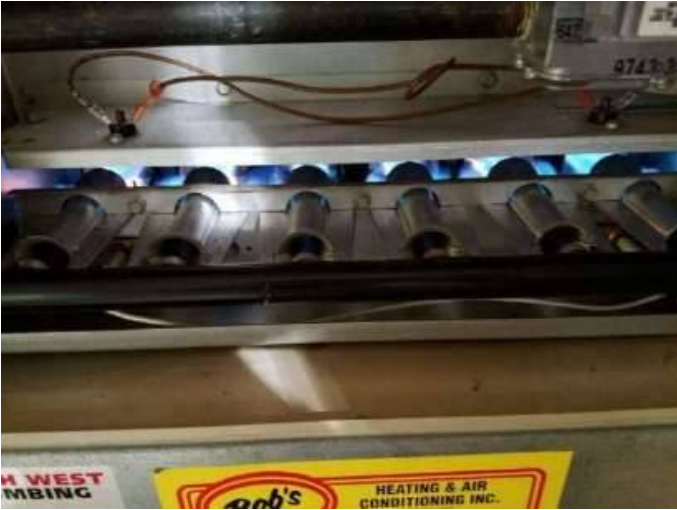
21 *Serviceable* - The home has a 20 year old Lennox propane furnace. It is in good operating condition. The burners, flame, combustion air, flue piping, ducting, and registers all appear to be in good condition. The furnace was serviced within the last year and does not need any maintenance at this time. It is generally recommended to have the furnace cleaned and serviced on a yearly basis. Note that furnaces typically last around 20-25 years if they are maintained and serviced frequently.

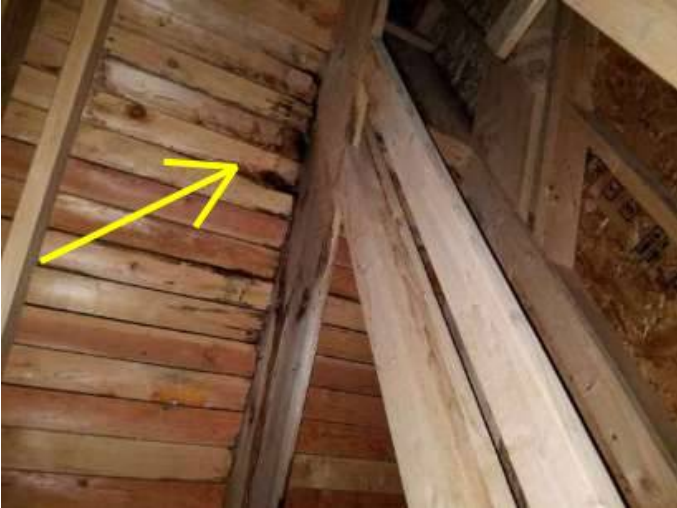
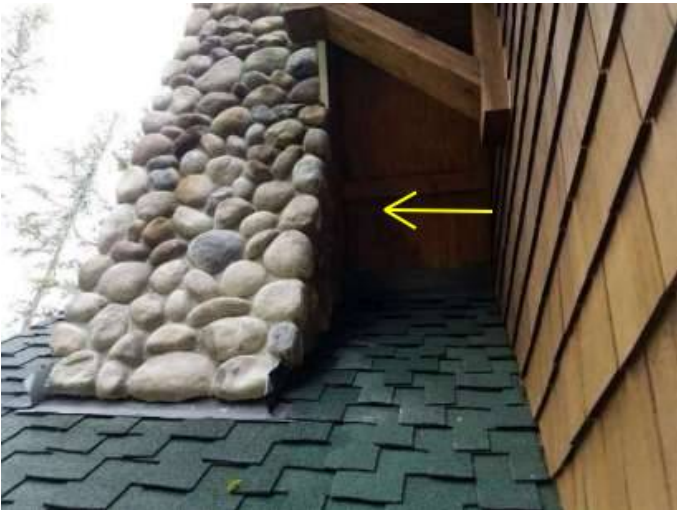
1 **Repair/Replace, Evaluate** - A leak was noted at the chimney. Flashings at the base of the chimney is substandard. Recommend that a qualified contractor evaluate and repair as necessary.

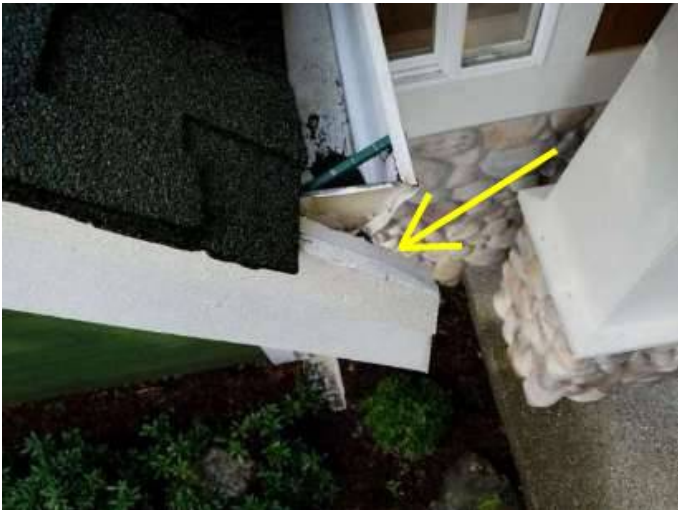
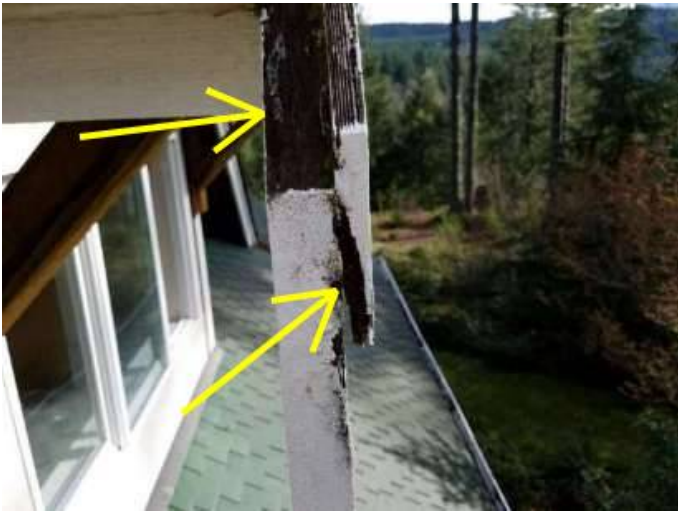
2 **Repair/Replace** - Barge boards, which are the trim boards at gable ends of roofs, were exposed at their lower ends, and some were rotten. Standard building practices call for shingles or flashing to be installed over them to prevent rot. Recommend that a qualified contractor replace rotten boards and install shingles or flashing over exposed barge board ends where missing.

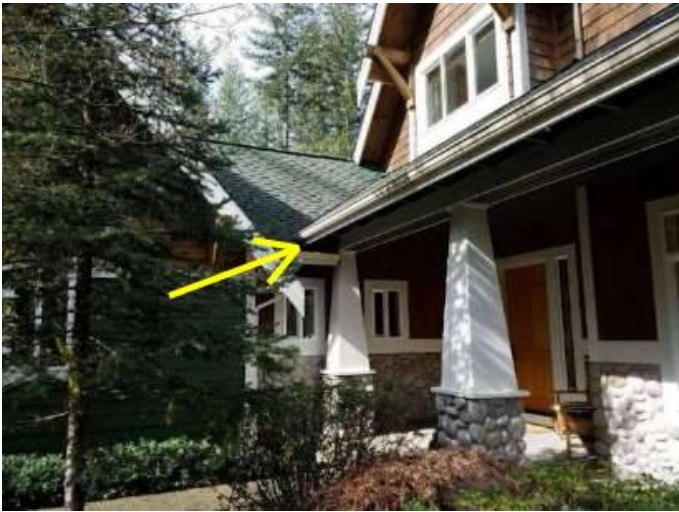
Photo 4-2

4) ***Repair/Replace*** - One or more downspouts terminated above a roof surface, and rainwater has damaged shingles on the roof surface below. This is a conducive condition for wood-destroying organisms. Downspout installations like this are common, but damage from concentrated rainwater run-off can reduce the life of the roof surface. Recommend that a qualified contractor replace damaged shingles as necessary. Recommend that a qualified person install downspout extensions where necessary to route the rainwater directly to the closest gutter below.

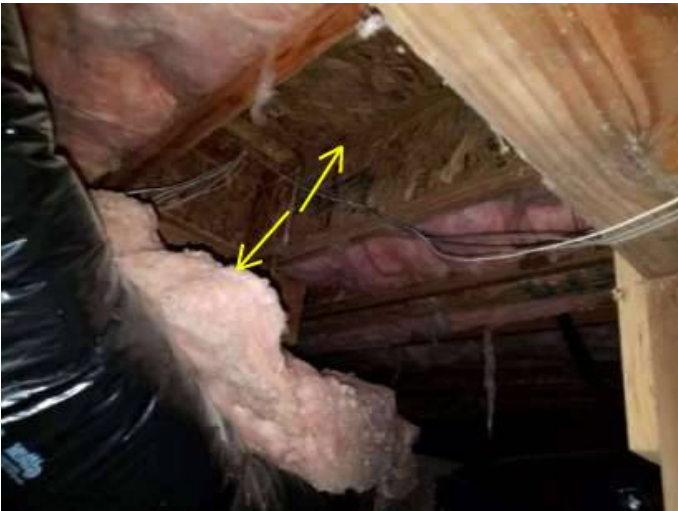
9 *Repair/Maintain* - Under-floor insulation was falling down in one area. This may result in reduced energy efficiency. We recommend that a qualified person repair or replace insulation as necessary.

Photo 9-1
Living room area

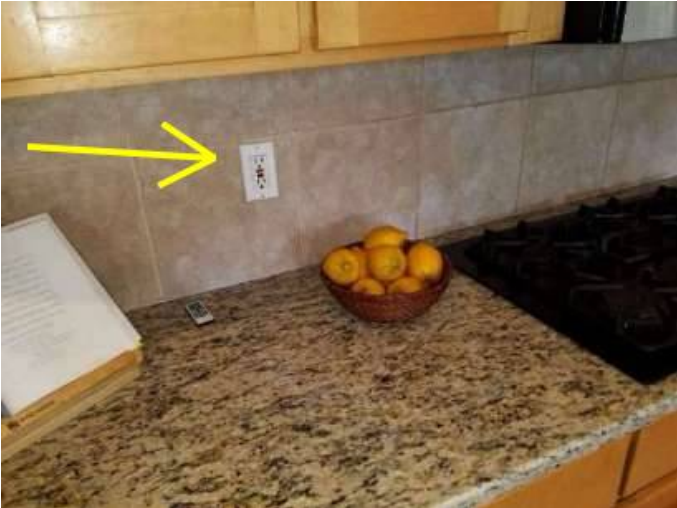
Photo 12-1

12 *Safety, Repair/Replace* - One or more ground fault circuit interrupter (GFCI) devices protecting receptacles at the kitchen wouldn't trip when tested. This is a potential shock hazard. Recommend that a qualified electrician evaluate and repair as necessary.

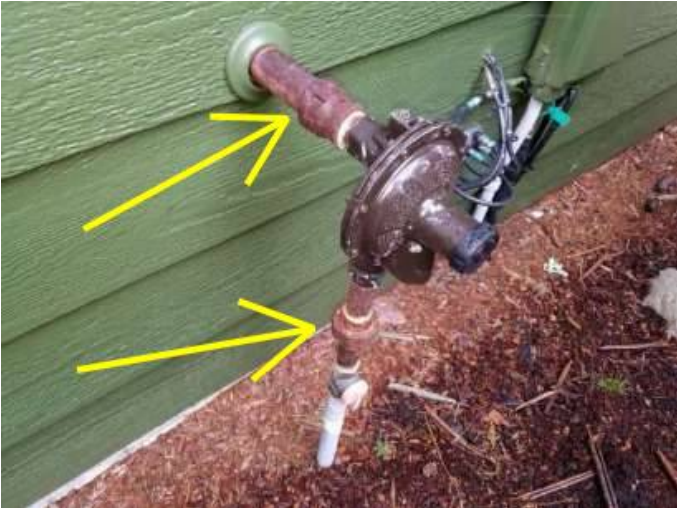
15 *Repair/Maintain* - Steel piping for the gas service located outside was significantly corroded. Gas leaks can result. Recommend evaluation by a qualified contractor to determine if piping needs replacing. If not, then a qualified person should prep and paint lines as necessary with a rust-preventative paint. Very corroded pipes should be replaced by a qualified contractor.

Photo 15-1
SW side of the home

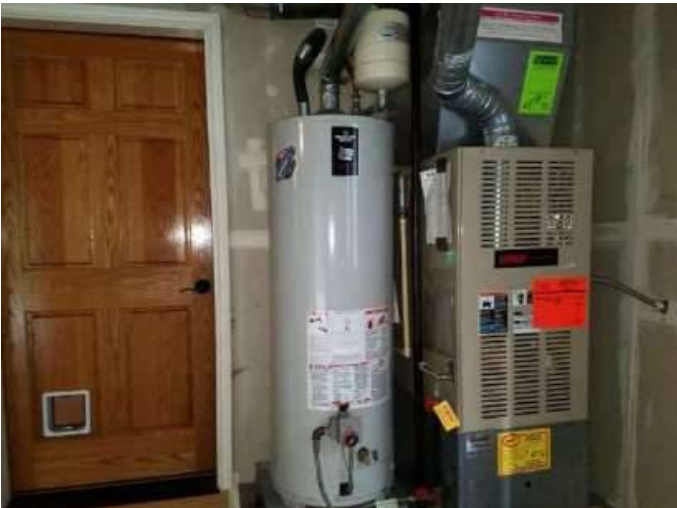
Photo 20-1

20 *Suggest Upgrade* - The water heater is a 20 year old Bradford White brand tank style propane heater with a 50 gallon capacity. It is in serviceable condition, however, it is beyond its expected lifespan and should be replaced as soon as possible. Note that the estimated useful life for most water heaters is 8-12 years.

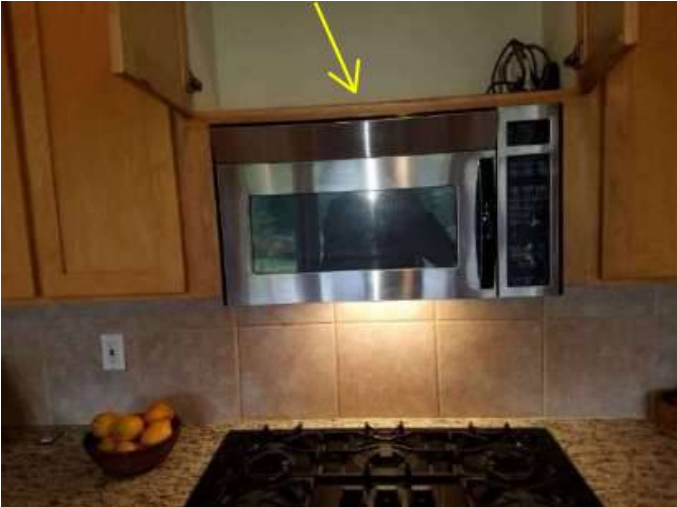
Photo 22-1

22 *Repair/Replace, Suggest Upgrade* - The exhaust fan over the range recirculated the exhaust air back into the kitchen. This may be due to no duct being installed, baffles not being installed, or problems with duct work. This can be a nuisance for odor and grease accumulation. Where a gas-fired range or cook top is installed, carbon monoxide and excessive levels of moisture can accumulate in living spaces. Recommend that a qualified contractor evaluate and repair as necessary so exhaust air is ducted outdoors.

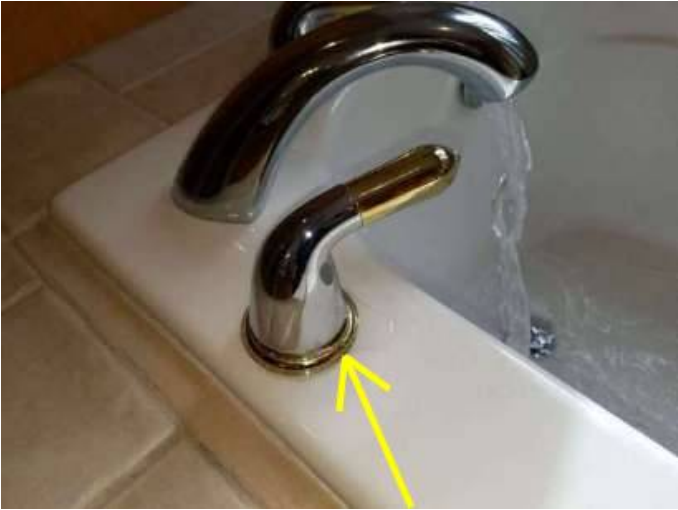
Photo 23-1

23 *Repair/Replace* - One or more bathtub faucet handles at the master bathroom tub were leaking. Recommend that a qualified person repair or replace handles as necessary.

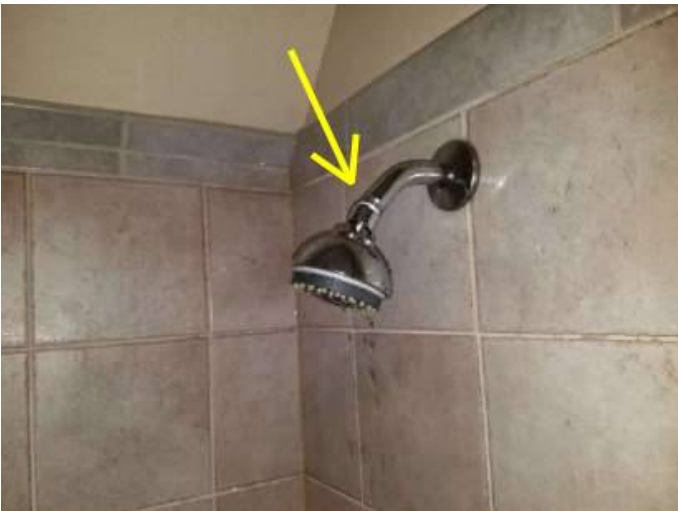
Photo 24-1

24 *Repair/Maintain* - The shower head at the 2nd floor hall bath was leaking. Recommend that a qualified person repair as necessary.

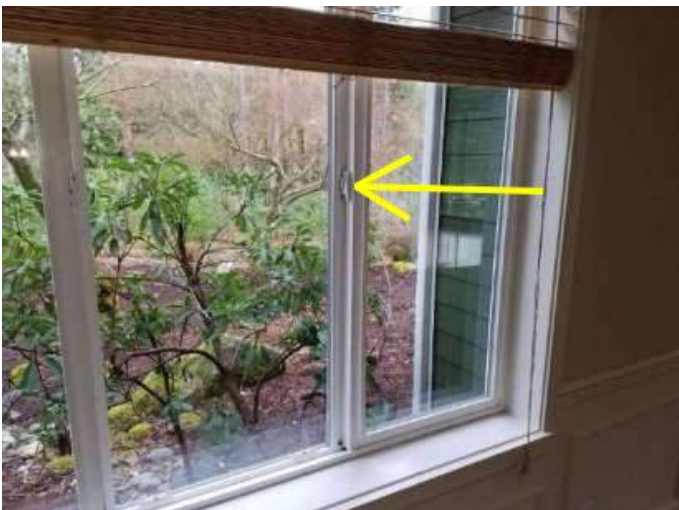
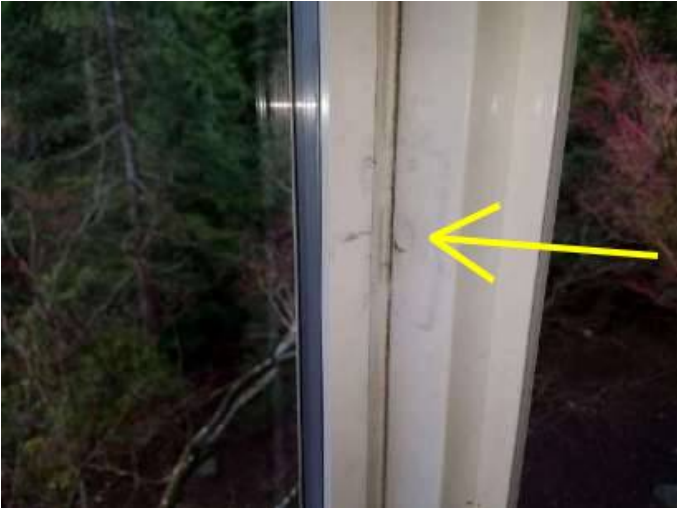
26 *Repair/Maintain* - Lock mechanisms on one or more windows were loose and/or missing. This can pose a security risk. Recommend that a qualified person repair as necessary.

Photo 26-1
Loose lock mechanism in the living room

Photo 26-2
Lock mechanism missing in the 2nd floor NW
bedroom

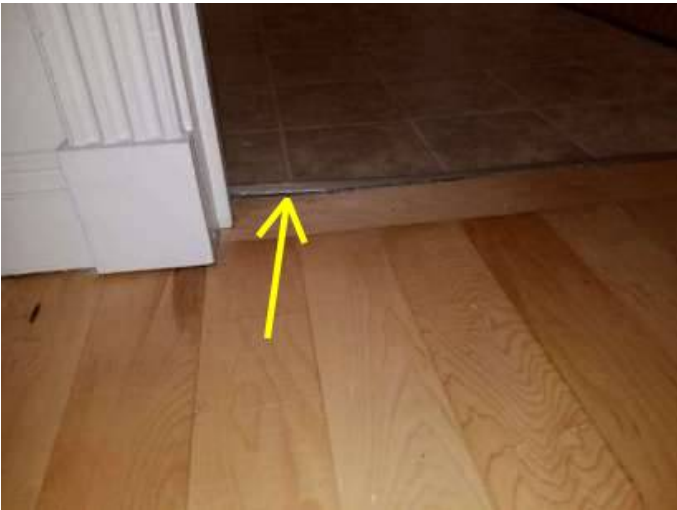
Photo 27-1

27 *Repair/Maintain* - A transition strip was loose at the laundry room. Recommend that a qualified contractor repair as necessary.

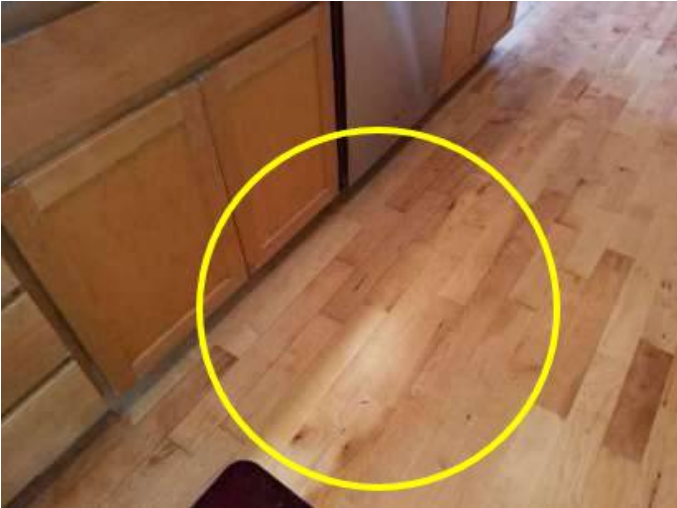
28 *Evaluate* - Wood flooring in one or more areas was cupping slightly. This may indicate that the floor has been exposed to water or that the flooring was not allowed to equalize in moisture content before being installed. Consult with the property owner and/or have a qualified specialist evaluate. It's likely that affected areas of the wood flooring will need to be refinished to obtain a flat surface. For more information, visit: <http://www.reporthost.com/?WDFLRPRB>

Photo 28-1
Kitchen floor in front of the sink and dishwasher

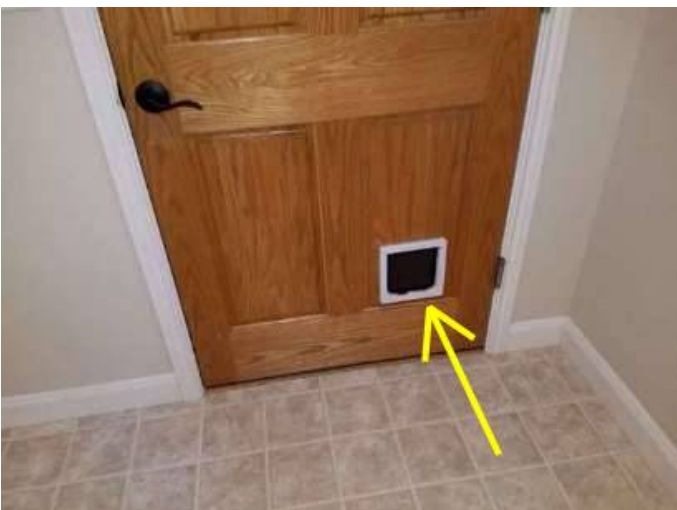
Photo 30-1

30 *Repair/Replace* - The door between the garage and the house has been modified with a pet door, and is no longer fire-resistant. This is a potential safety hazard. House to garage doors, to prevent fire and fumes from spreading from the garage into interior living space, should be constructed of fire-resistant materials. Doors, generally considered to be suitable for the purpose, are solid core wood, steel, honeycomb steel or a door that has been factory labeled as fire rated. Recommend that a qualified contractor replace or repair the door and, at that time, make any other corrections that might be required to provide suitable fire resistance between the garage and the dwelling per standard building practices. For more information, visit:

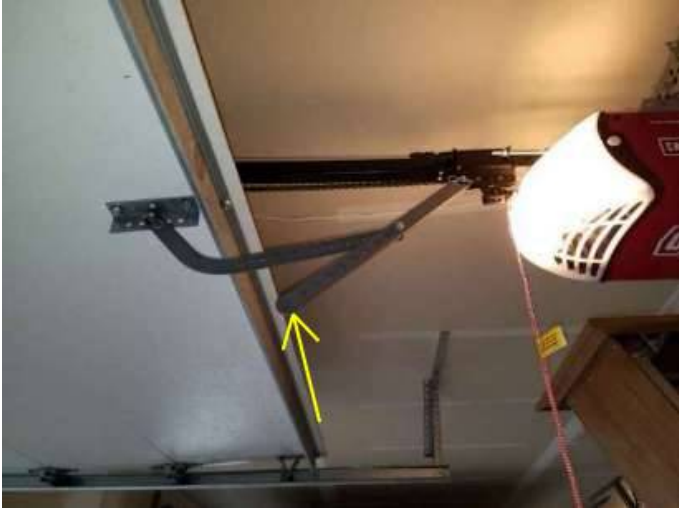
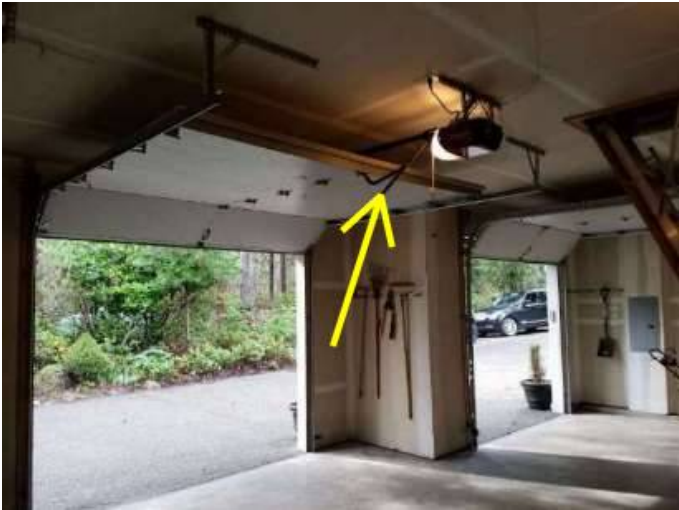
31 *Repair/Maintain* - One or more automatic door openers were loose and/or missing hardware.

Photo 31-1
Missing bolt

Recommend that a qualified contractor evaluate and repair or opener(s) as necessary.
